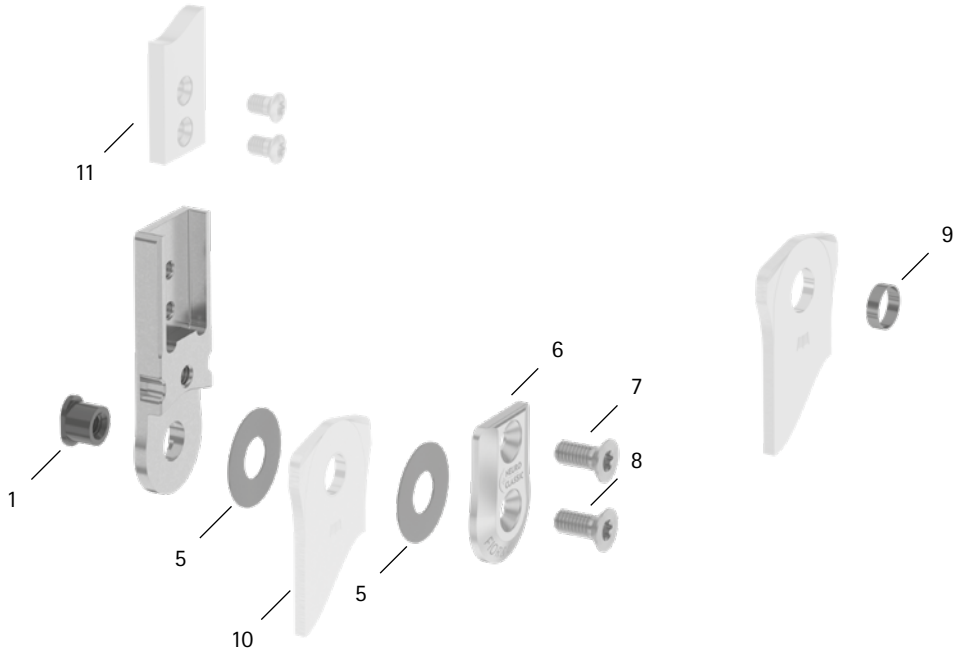
Item	24mm	Description	Potential Problem	Measure	Recommended Inspection, Potential Replacement*	Latest Replacement after
System Joint						
1	SB1262-L1190	bearing nut, short**	wear	replacing	every 6 months	36 months
5	GS3013-040	sliding washer, Ø = 30mm	wear	replacing	every 6 months	18 months
5	GS3013-045					
5	GS3013-050					
5	GS3013-055					
5	GS3013-060					
6	SF0167-3/AL	cover plate**	wear	replacing	every 6 months	36 months
7	SC1416-L16	countersunk flat head screw with hexalobular socket**	wear	replacing	every 6 months	36 months
8	SC1416-L16	countersunk flat head screw with hexalobular socket (axle screw)**				
1, 6-8	SF1987-AL	functional unit plug + go modularity***	loss of function, wear	replacing	every 6 months	36 months
System Stirrups, System Anchors and System Side Bars						
9	BR1413-L070	sliding bushing	wear	replacing	every 6 months	18 months
10	see catalogue	system stirrup	wear or breakage	replacing	every 6 months	48 months

11	see catalogue	system anchor and system side bar	wear or breakage	replacing	every 6 months	if required
